# **Joint Test Report**

## **For Validation of Alternatives to Aliphatic Isocyanate Polyurethanes**

**FINAL**  
**NASA.PROJ.JTR.AIU.PL.08.31.07.F**

**August 31, 2007**

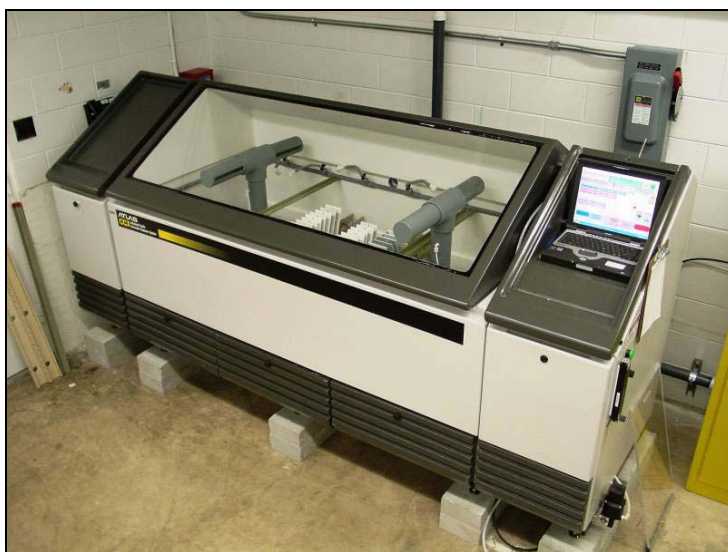
**Figure 4-11 Cyclic Corrosion Chamber**

The coupons were placed on non-conductive racks at a 30° angle in an Auto-Technology CCT-NC-40 programmable cyclic corrosion chamber (Figure 4-11).

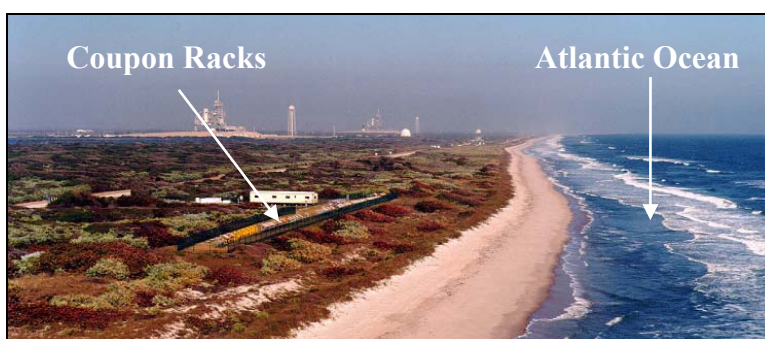
**Figure 4-14 Beach Corrosion Test Site at KSC**

The rating process consisted of adhesion testing of the primers, gloss measurements, and visual ASTM evaluations of the coated surfaces. Photographs were taken at the start of the 18-month exposure period. After all coating systems were applied and allowed to cure, the coupons were mounted on test racks and transported to the KSC Beach Corrosion Test Site stands. This site is located approximately 1.5 miles south of Launch Complex 39A at KSC (Figure 4-14). The coated test panels were installed on stainless steel racks that use porcelain insulators as standoffs. The racks were installed on galvanized pipe test stands which oriented the samples at a 30° angle facing the ocean. The distance of the test stands from the mean high-tide line is approximately 30 meters (100 feet) from the Atlantic Ocean.

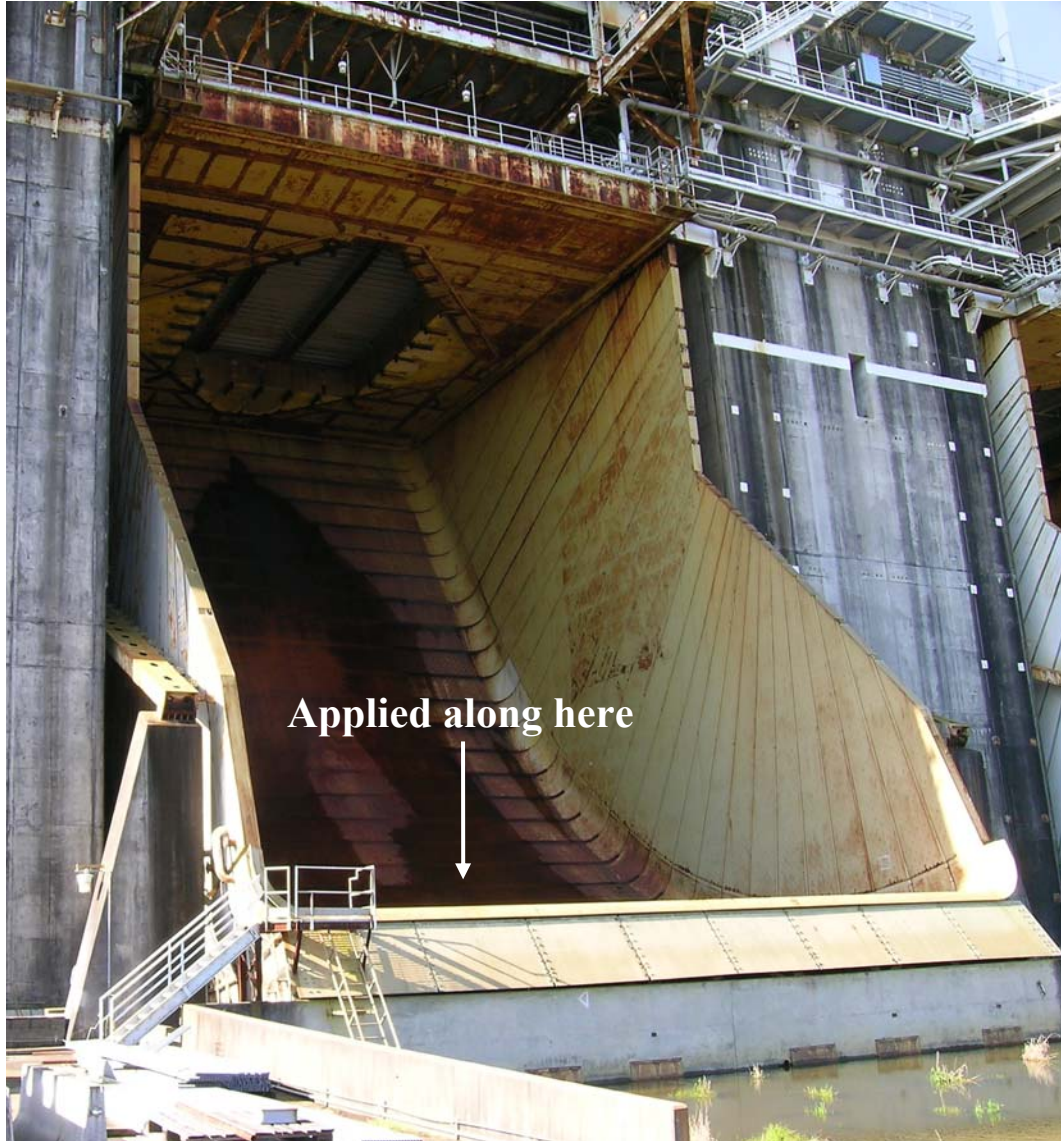
**Figure 5-1 Photograph of Field Application Site at SSC**

aluminum oxide to a *White Metal Blast Cleaning* condition (SSPC SP5) before masking 3'× 3' sections and applying the respective coating systems (Figures 5-1 and 5-2).
